Report No. CETHA-BC-CR-90017

Task Order 2 Enhanced Preliminary Assessment

HAMILTON ARMY AIRFIELD
NOVATO, CALIFORNIA

January 1990

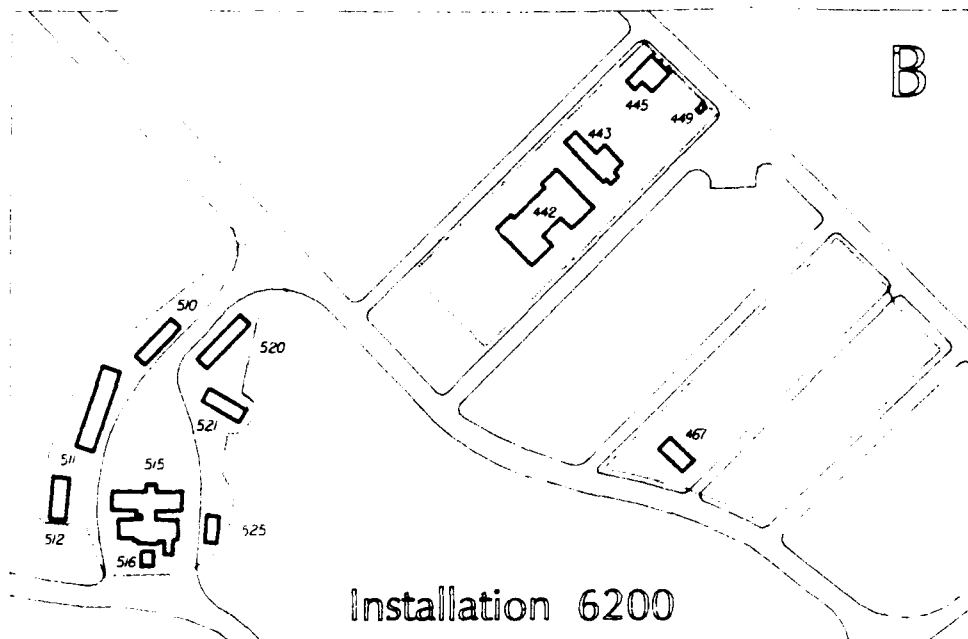
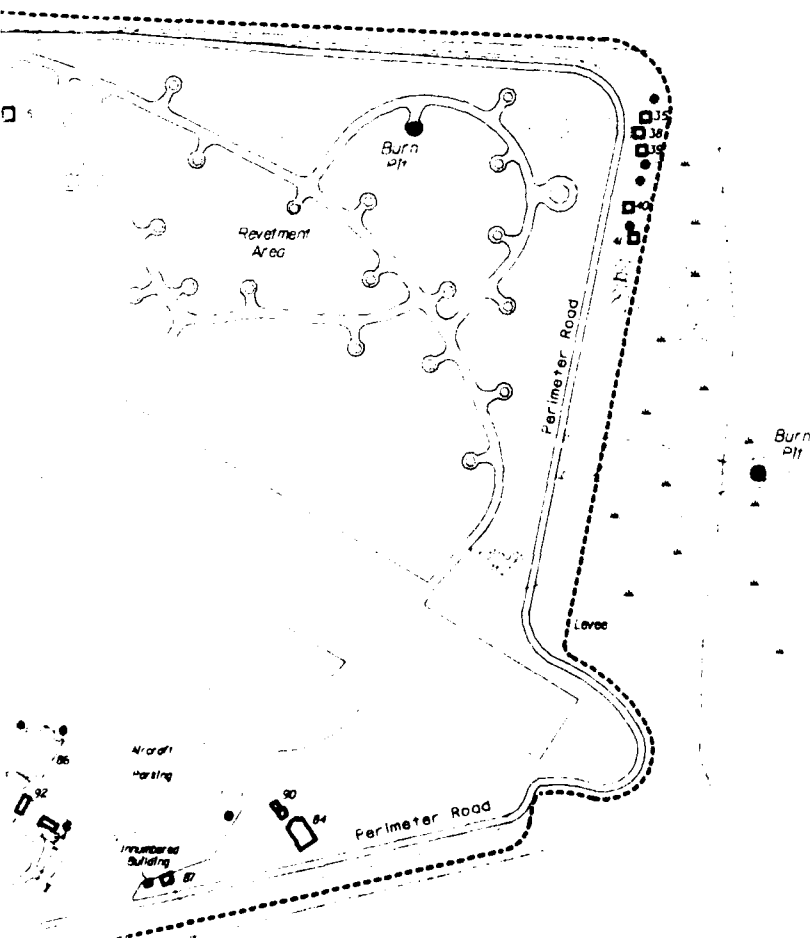
Figure 3-1
Environmentally Significant
Operations

the ground near where they had been used. Reports from HAA personnel indicate that no PCB transformers exist on HAA; however, no documentation or transformer inventory could be found by environmental personnel at The Presidio or Sacramento COE to verify this information [T-1, T-6, T-7]. The exact locations of all transformers within HAA are unknown, and, therefore, are not shown in Figure 3-1.

ASTs are located in several areas within HAA (Figure 3-1). The following is a list of known existing and removed tanks, including available information on each tank. In many cases, little historical data exist. Information in this section has been paraphrased from a report issued by International Technologies [R-2]; however, the information and results could not be verified during WESTON's onsite inspection.

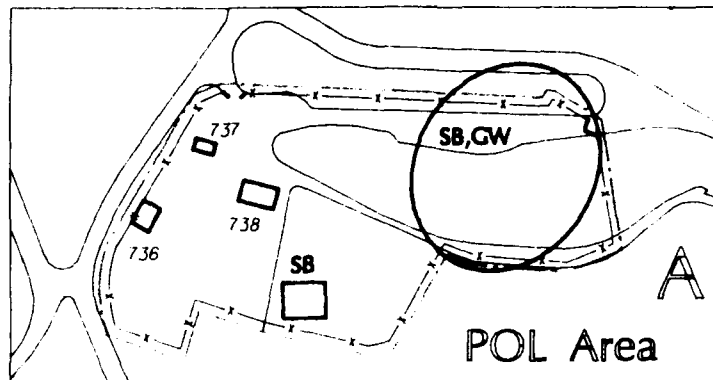
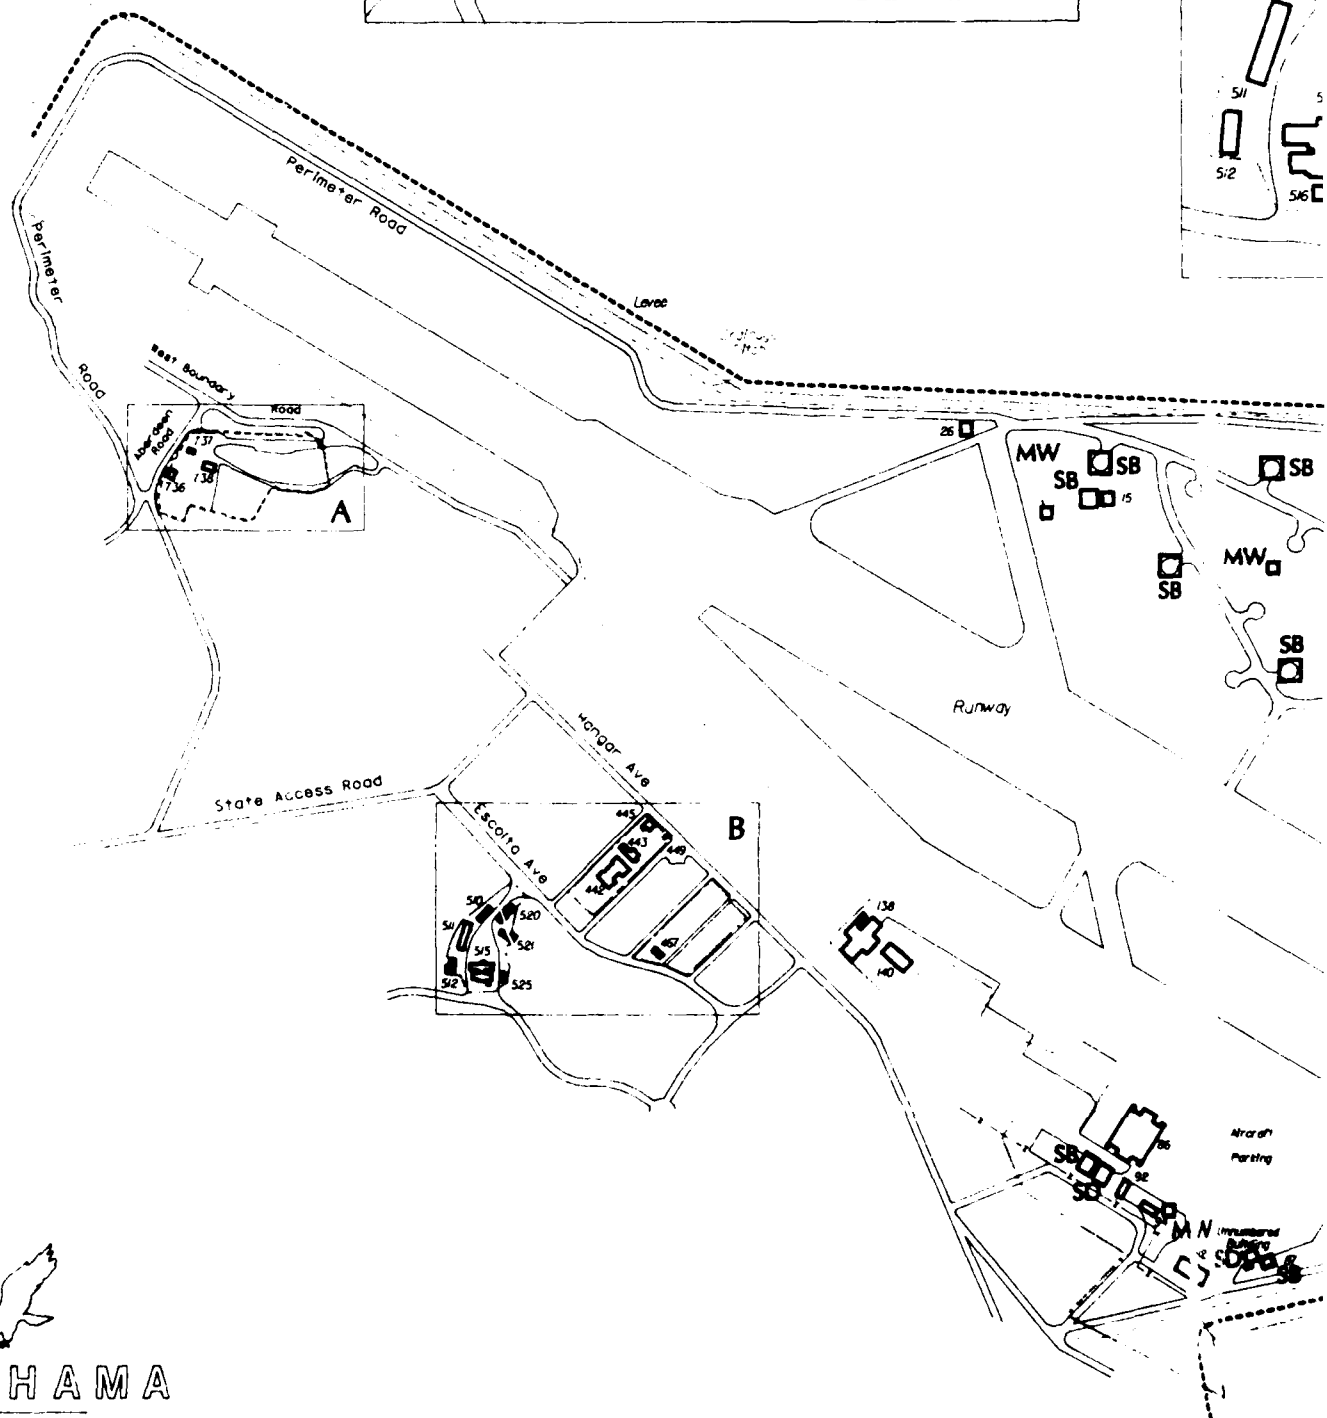
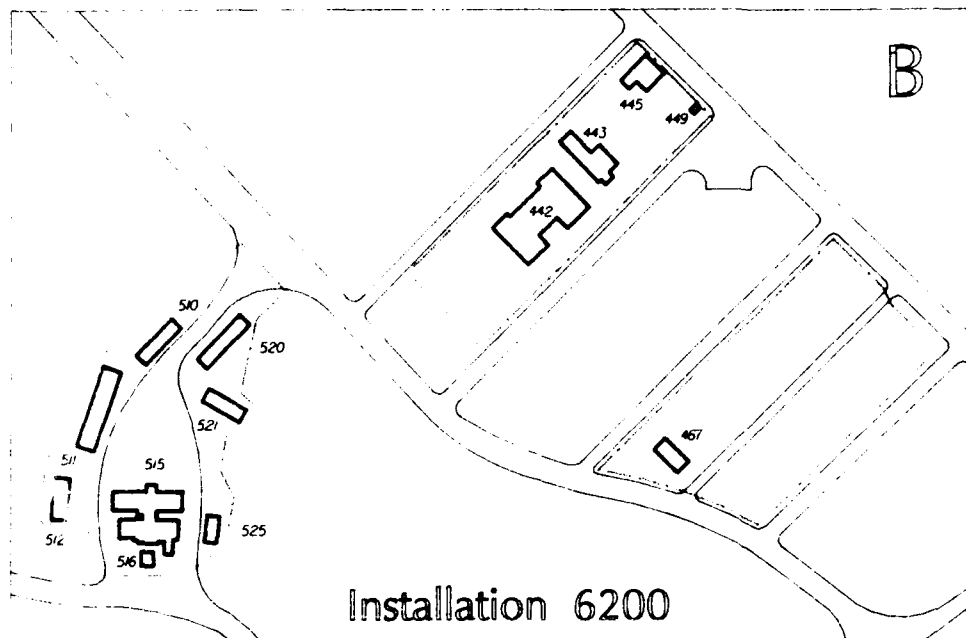
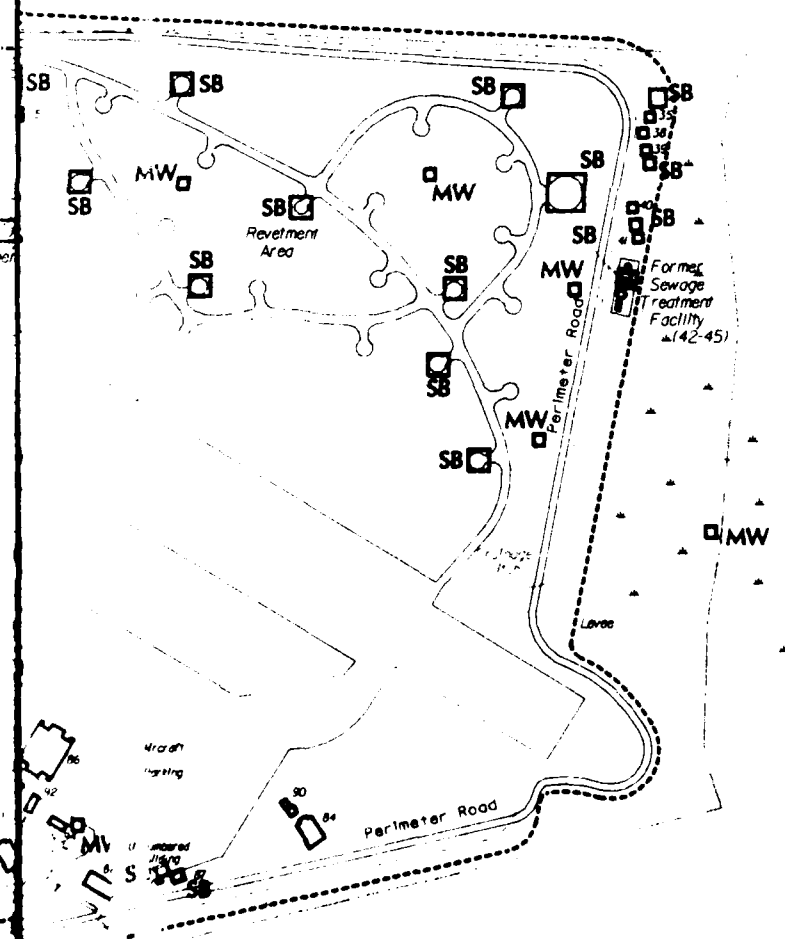
Figure 5-1
Recommended Sampling
Locations

Table 5-1 outlines recommended actions for the ESOs located on HAA. Figure 5-1 shows proposed sampling locations. Recommendations are discussed in the following subsections.

It is recommended that the soil under AST 5 (at Building 35) be sampled. Soil staining seen adjacent to AST 5 (photo 7) was probably due to a fill pipe leak. Two soil samples, each taken at 0 to 6 in. and 2 to 3 ft, are suggested. Samples should be analyzed for TPHs.

In addition to the soil samples, 4 wells should be placed in the approximate locations shown in Figure 5-1. One sample should be collected from each well and analyzed for TPHs, RCRA metals, VOCs, and BNAs.
